Complex Pelvic Fractures: Emergency Room to Internal Fixation - A Case Series And Literature Review

Keywords: Pelvic fracture, damage control surgery, Young and Burges, internal fixation

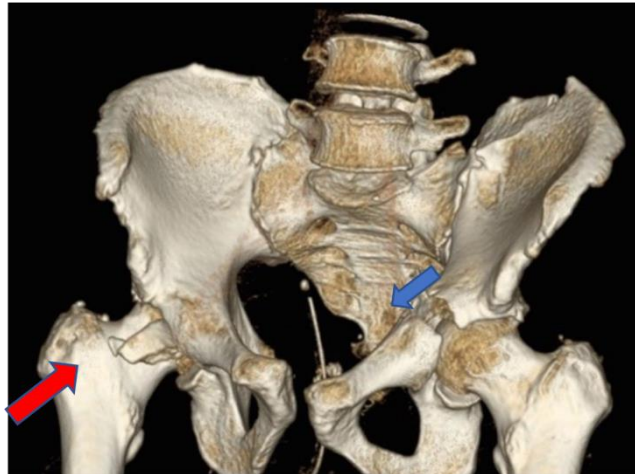
Figure I (Case One): 3-D CT pelvic re-construction antero-posterior view showing pubic symphysis disruption >2.5cm and a complete fracture through the left superior pubic ramus (blue arrow) and left iliac crest. A posterior dislocation of the right hip with a fractured posterior acetabular wall (red arrow) can also be seen.

unstable secondary to blunt abdominal trauma with a grade III liver injury, as well as a retroperitoneal hematoma from a Young-Burgess mixed, antero-posterior compression type grade III, and lateral compression type I, pelvic fracture with pubic symphysis disruption >2.5cm and a complete fracture through the left superior pubic ramus and left iliac crest. Furthermore there was an associated posterior dislocation of the right hip with a fractured posterior acetabular wall. He was resuscitated in the emergency department and as part of this process a pelvic sheet was initially placed and shortly replaced with an external pelvic fixation device. A full body CT scan revealed non surgical head injury, blunt chest trauma with left sided rib fractures and pulmonary contusions, blunt abdominal trauma with the grade III liver injury, hemoperitoneum, and extra-peritoneal bladder rupture. As part of this process a 3-D CT pelvic re-construction was created. [Fig 1-III].

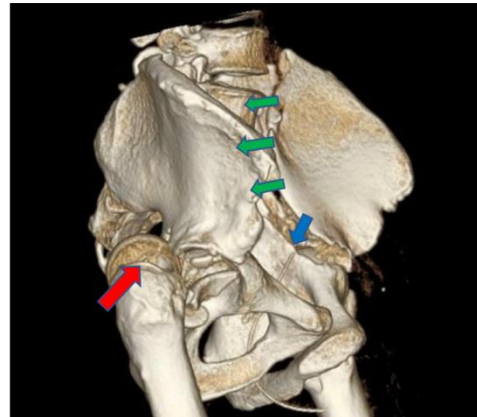
Figure II (Case one): 3-D CT pelvic re-construction lateral view where the pubic symphysis disruption >2.5cm, the complete fracture through the left superior pubic ramus (blue arrow), and left iliac crest (green arrows) can be better appreciated. The posterior dislocation of the right hip with a fractured posterior acetabular wall can also be seen (red arrow).

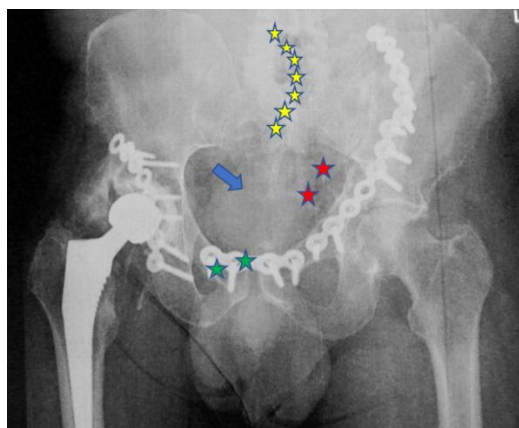
Figure V (Case one): Antero-posterior pelvic X-ray taken at 4-months post operatively, demonstrating both fracture union and satisfactory pelvic alignment. The pubic symphysis plate and right sided hybrid total hip replacement augmented by a posterior acetabular pelvic reconstruction plate are clearly visualized. On the left side the 2 screws fixing the pelvic reconstruction plate medial to the superior pubic ramus fracture line, can be seen (green stars). The 2 empty holes are then visualized as the plate passes over the fracture line on the superior pubic ramus (blue arrow). Once across this fracture line the same plate is secured with 2 screws into the dense supra-acetabular bone (red stars). The pelvic reconstruction plate is then coursed superomedial crossing the fracture line on the iliac crest and secured medially in a curvilinear manner to increase the pull-out strength with 7 additional screws (yellow stars).

He was assessed utilizing the Majeed Pelvic Score,⁹ and his score of 74 was interpreted as a good functional outcome. A follow-up X-ray confirmed fracture union and the pelvic alignment was satisfactory [Figure V]. He continued with his outpatient rehabilitation appointments and was booked for 1-year review.

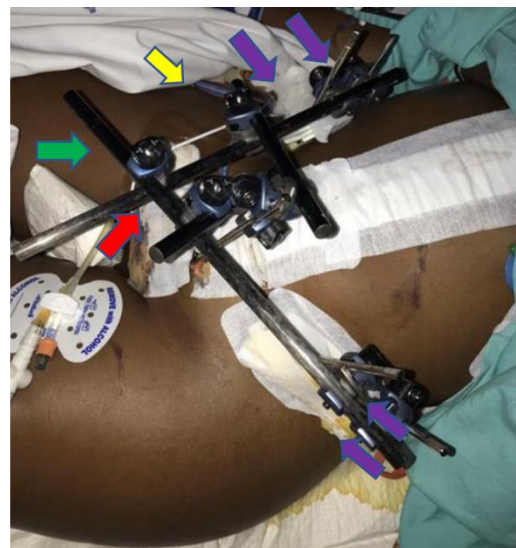
Figure VIII (Case two): Intra-operative patient photograph after laparotomy showing the final external pelvic fixation device in place. The arrow colors marking the Schanz screws correspond to those in Figure VII above.

liver laceration sutured and the shattered spleen removed. The left hip dislocation was reduced by closed means and intra-operative fluoroscopy was used to add additional Schanz screws and adjust the external pelvic fixation device to ensure pelvic reduction and temporary stabilization had been achieved [Figure VII-VIII].

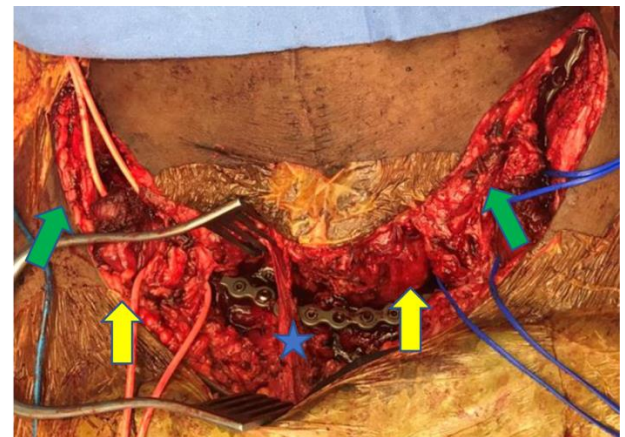
Figure XII (Case two): Intra-operative patient photograph showing the vascular loops behind the left and right neurovascular bundles (red arrows). Additional loops are noted beneath the left and right psoas muscle tendons (green arrows). The central pelvic reconstruction plate can be seen straddling the pubic symphysis (blue star).

removed. A bilateral ilioinguinal approach was used whereby the femoral vessels and nerves and psoas muscle were identified and isolated with vascular loops. A 5-hole pelvic reconstruction plate was then placed centrally over the pubic symphysis and leaving the central hole empty, 2 screws were inserted in to the 2 holes on either side of the midline. A second pelvic reconstruction plate was then slid beneath the right neurovascular bundle and used to plate across the fractured right superior pubic ramus. A 3rd pelvic reconstruction plate was then slid beneath the left neurovascular bundle and used to plate the fractured left superior pubic ramus [Figure XII].

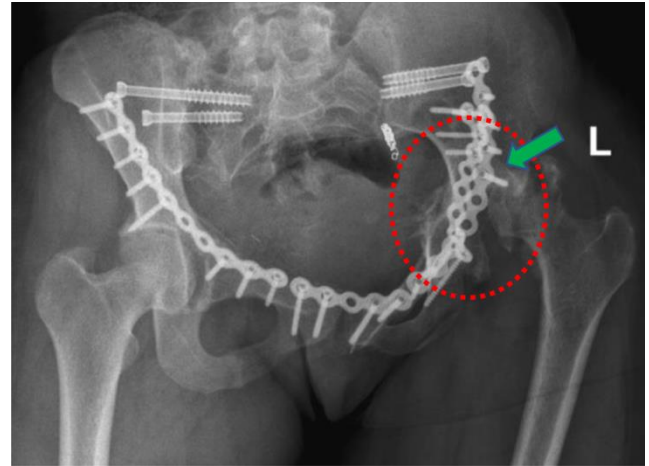
Figure XIV (Case two): Anteroposterior pelvic X-ray taken at 6-months post injury- showing healed bilateral superior pubic ramii fractures and right inferior pubic ramus fracture. On the left side the femoral head is noted to have undergone avascular necrosis (red dotted circle) and had subluxated posteriorly (green arrow).

limited to 10 degrees. An anteroposterior pelvic X-ray confirmed avascular necrosis of the left femoral head which had subluxated posteriorly. The same bony fragment from the posterior acetabular wall was noted to have refractured, and had displaced posteriorly [Figure XIV].

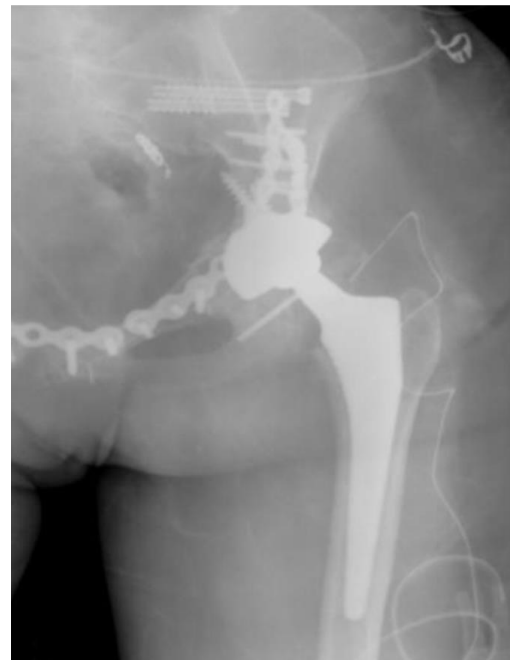
Figure XV (Case two): Intra-operative fluoroscopic X-ray showing the left non-cemented total hip replacement.

pelvic X-ray confirmed the extensive pelvic reconstruction and now in addition showed the left total hip replacement in situ [Figure XV].
